**DOT/FAA/AR-96/21**

# **Composite Failure Analysis Handbook Update 1**

**WL-TR-93-4004**

August 1997

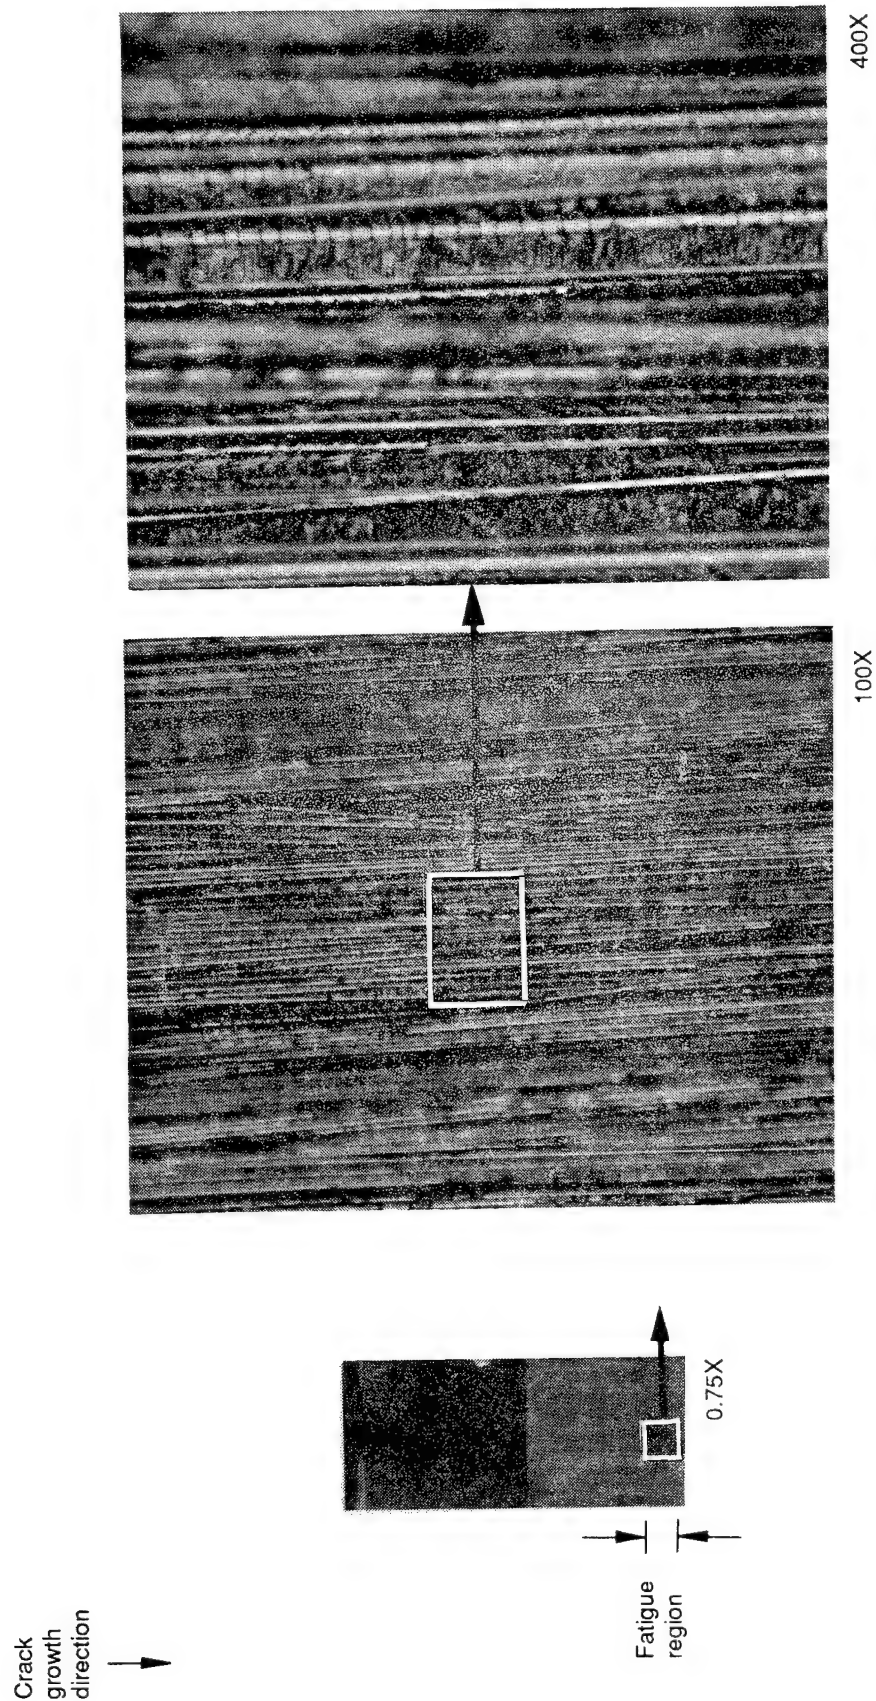
The typical mode II crack propagation features were easily identified on the surfaces of both specimens. In addition, indications of fatigue loading, in the form of fatigue crack growth increments or striations, were visible on the low-stressed specimen. They were observed only on the exposed fibers at the high optical and SEM magnifications. Even though the high-stressed fracture surface was thoroughly examined, no striations were found. Figures 3.1-1 through 3.1-4 show optical and SEM fractographs of interlaminar mode II fatigue at high and low stress levels.

Figure 3.1-1. Optical Fractographs of 3501-6/AS4 Interlaminar Mode II (Shear) Fatigue, Low Stress Loading, 270°F

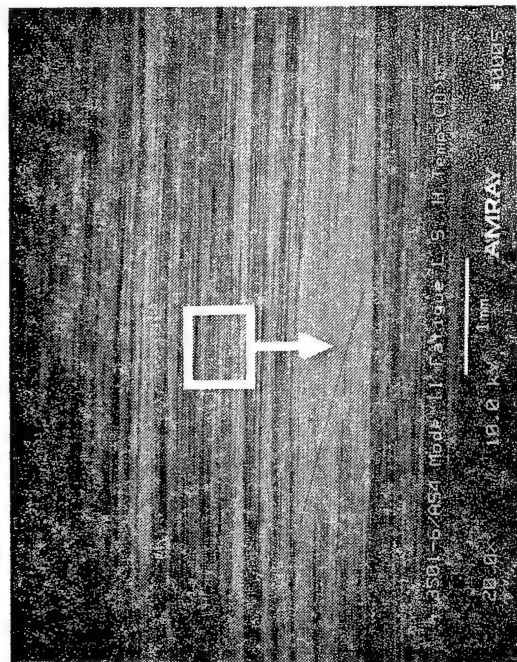
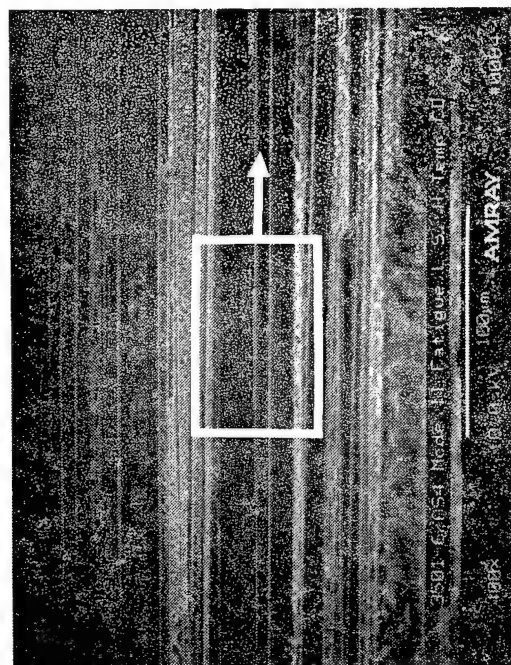
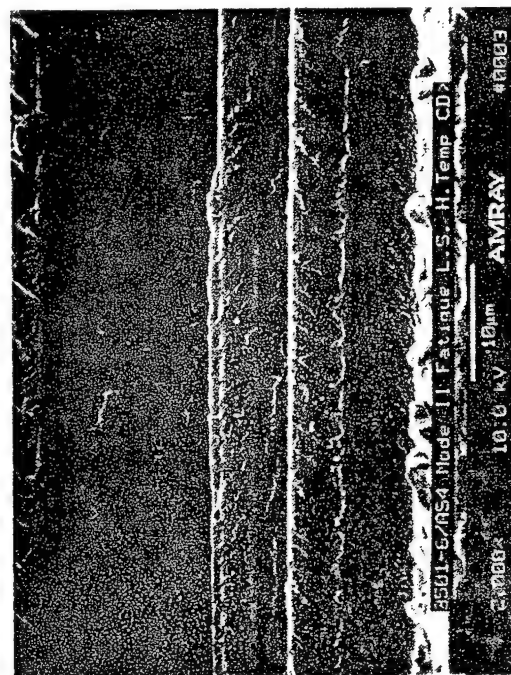
Figure 3.1-2. SEM Fractographs of a 3501-6/AS4 Interlaminar Mode II (Shear) Fatigue Fracture Surface, Low Stress, 270°F

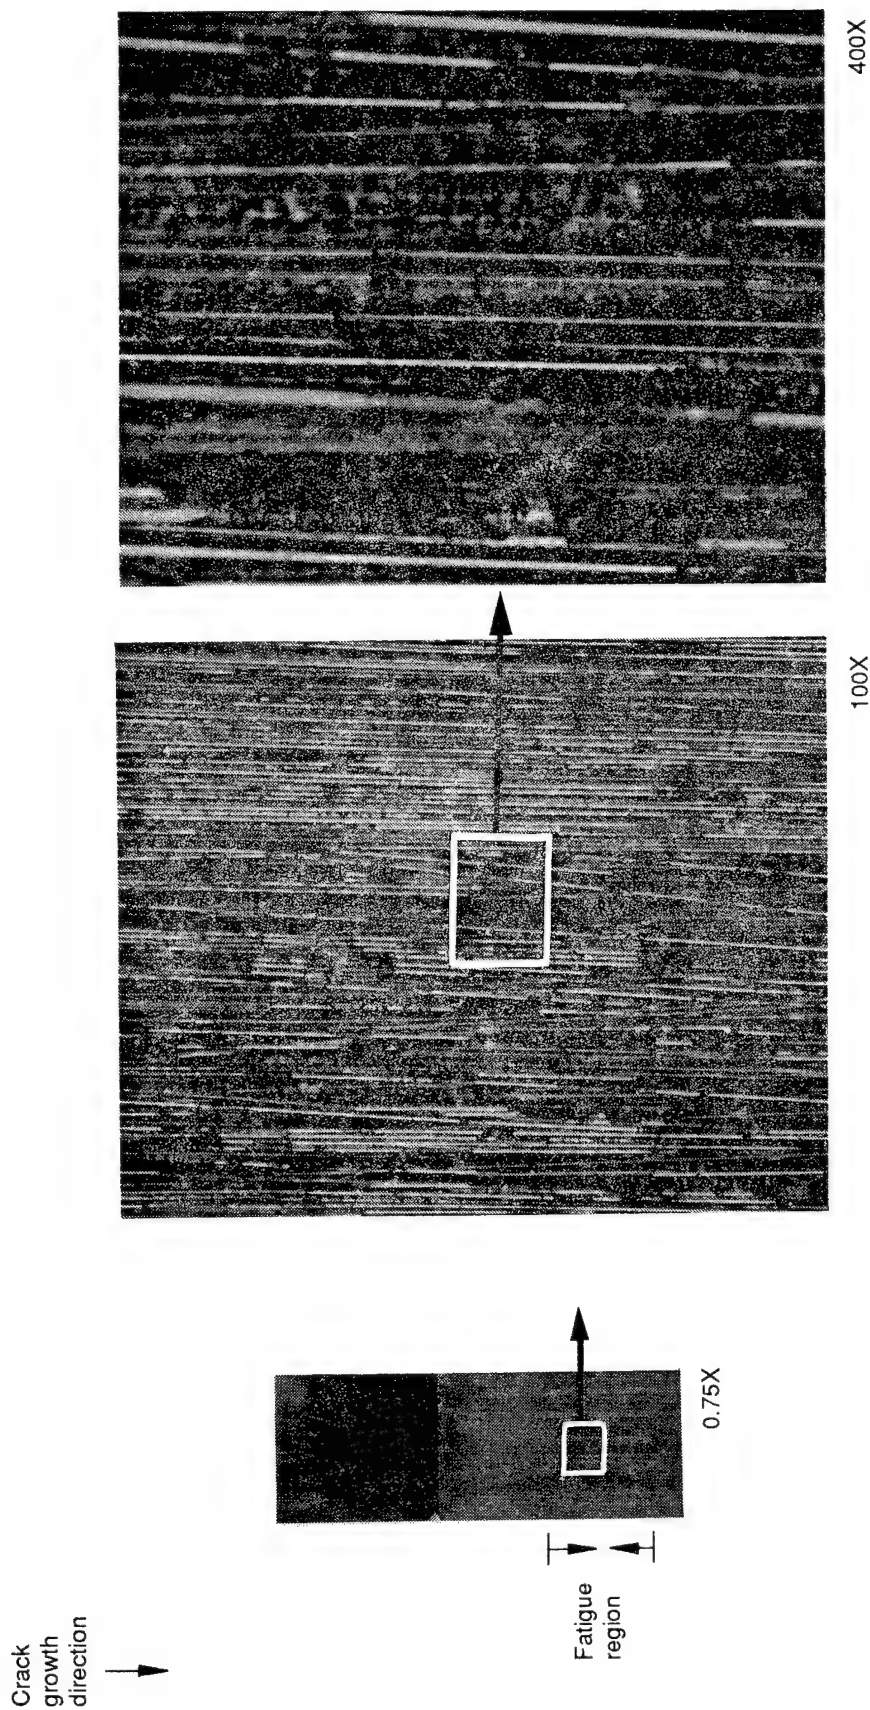
Figure 3.1-3. Optical Fractographs of 3501-6/AS4 Interlaminar Mode II (Shear) Fatigue, High-Stress Loading, 270°F

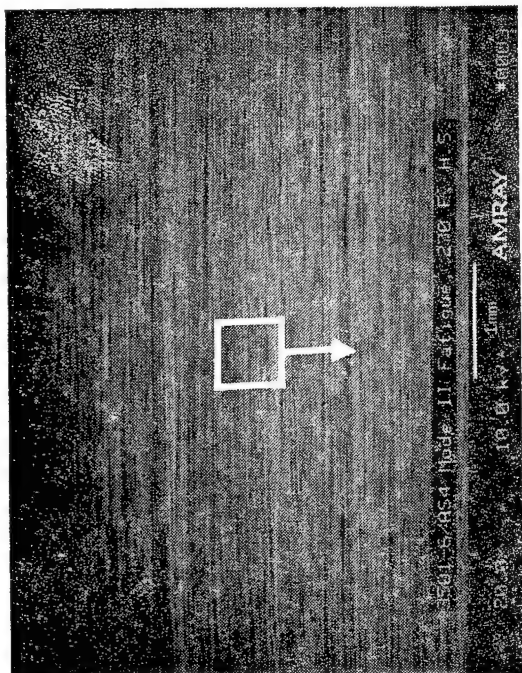
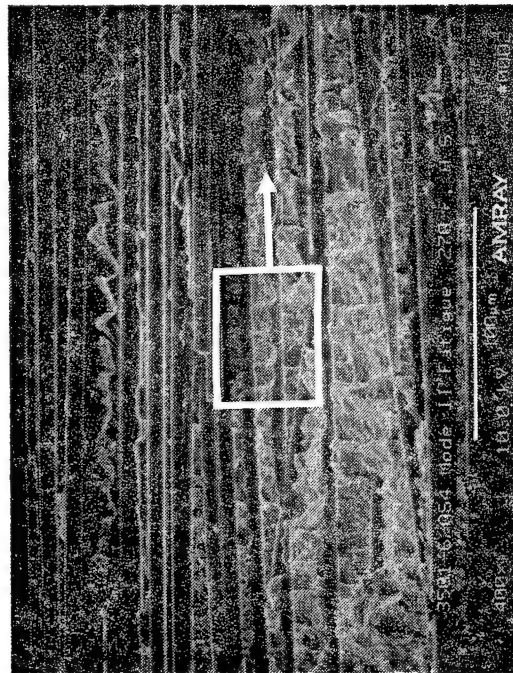
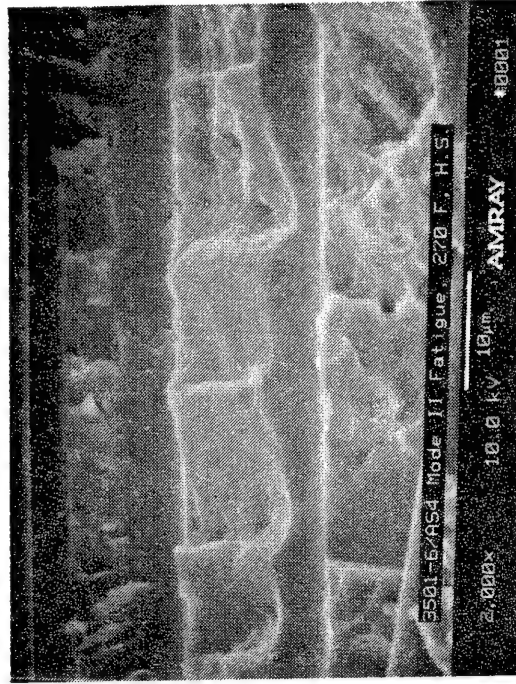
Figure 3.1-4. SEM Fractographs of a 3501-6/AS4 Interlaminar Mode II Fatigue Fracture Surface, High Stress, 270°F

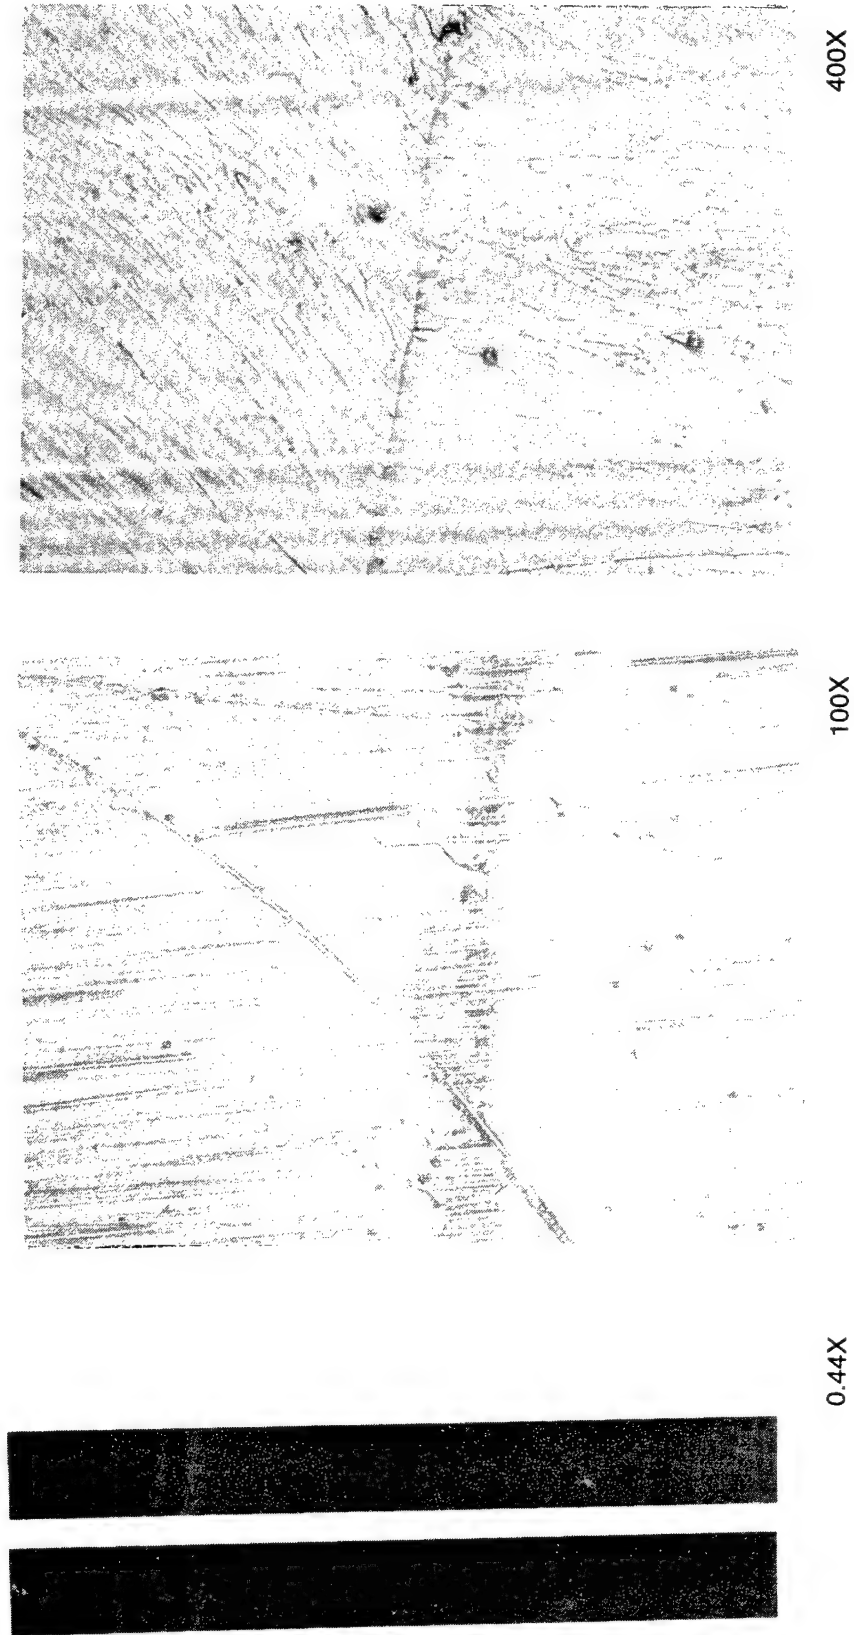
The mode I crack propagation features were not easily seen on the fracture surfaces (Figures 3.1-5 & 3.1-6) unlike a typical static load fracture surface. There were more features indicative of mode II (shear), such as hackles, throughout the surfaces. But these corresponded to the fiber pullout fractures than the overall crack propagation. Neither did these features generally indicate the overall crack propagation direction.

Figure 3.1-5. Optical Fractographs of a 3501/AS4 Interlaminar Mode I (Tensile) Fatigue Fracture Surface, 270° F

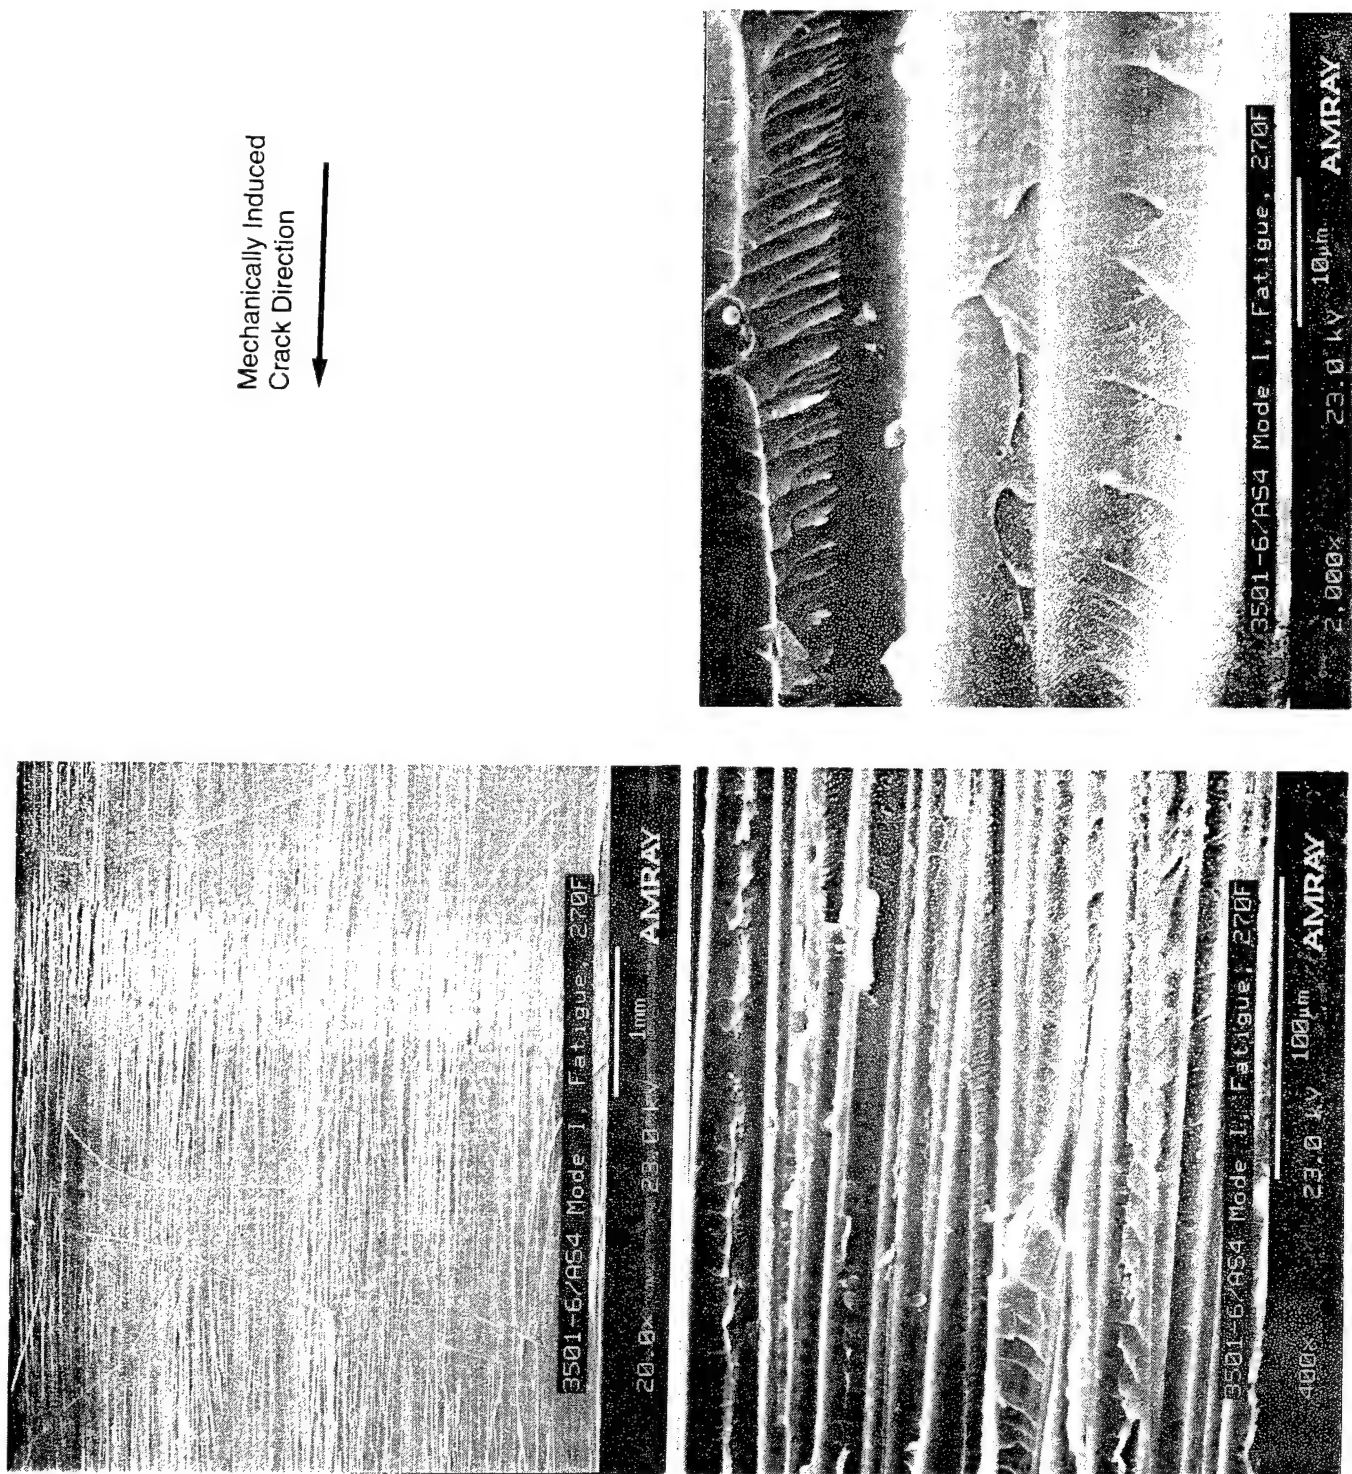
Figure 3.1-6. SEM Fractographs of a 3501/AS4 Interlaminar Mode I (Tensile) Fatigue Fracture Surface, 270° F

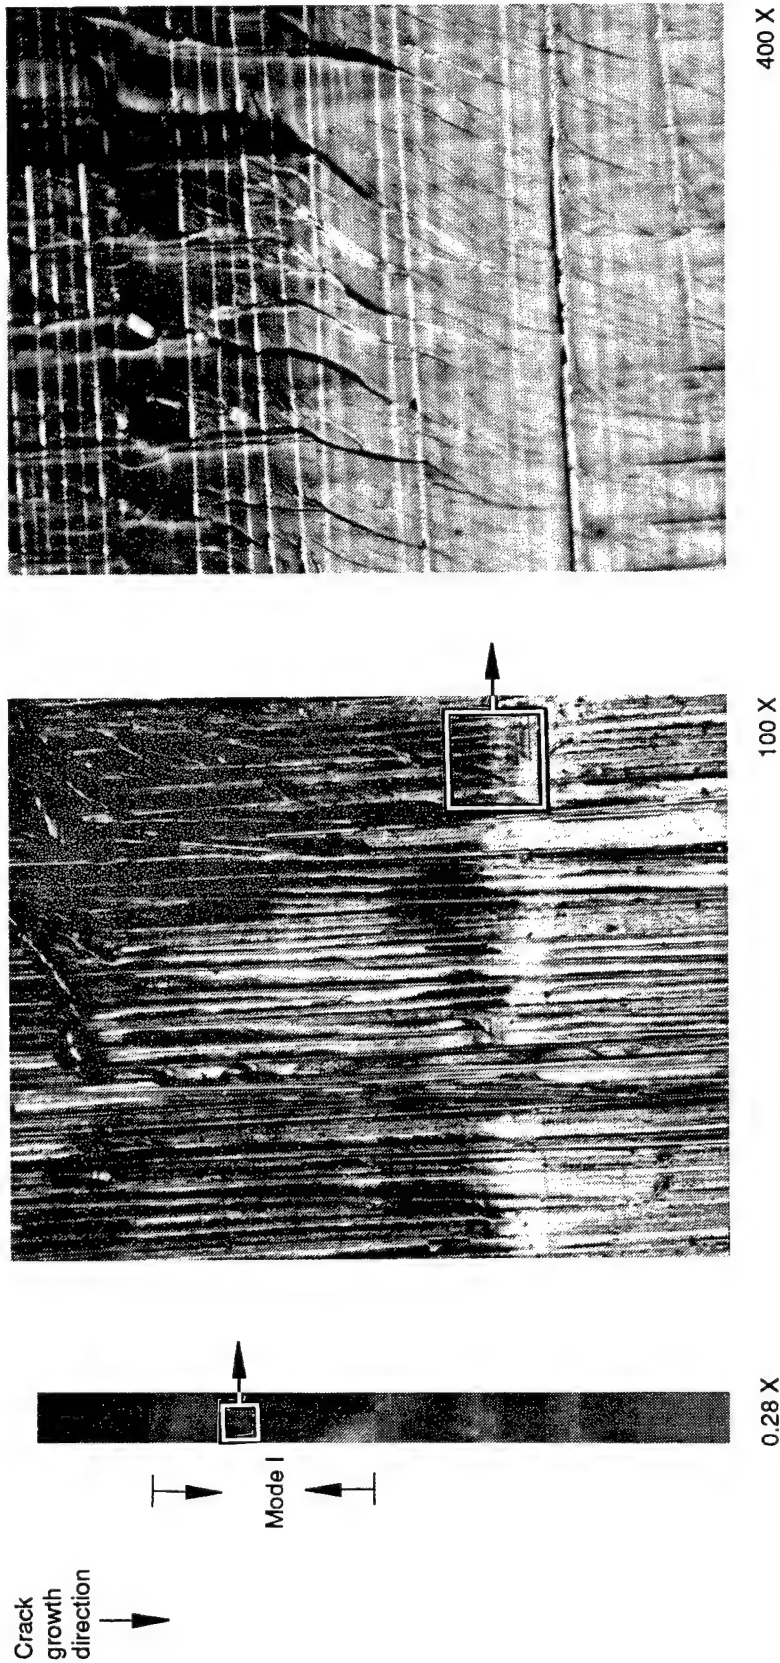
Following the exposures, the specimens were then tested and examined. Fractographic analysis of the surface morphologies revealed no abnormal or unusual surface features on any of the specimens.

Figure 3.1-7. Optical Fractographs of 3501-6/AS4 Interlaminar Mode I Tension, Specimen Exposed to Deicing Fluid

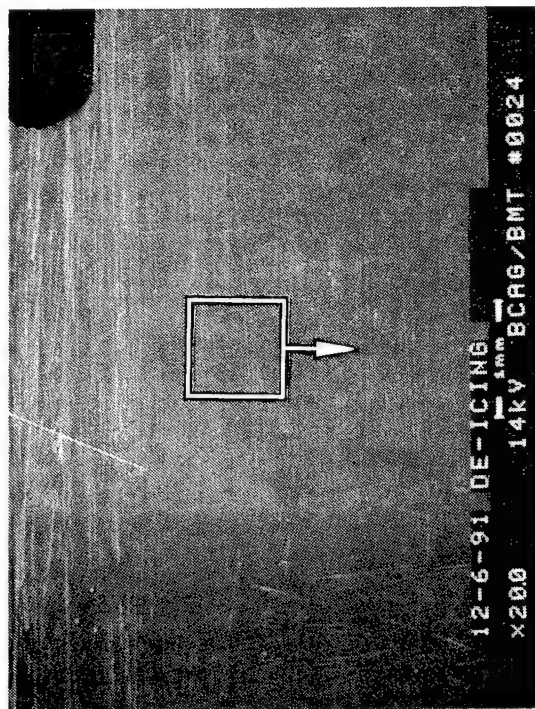
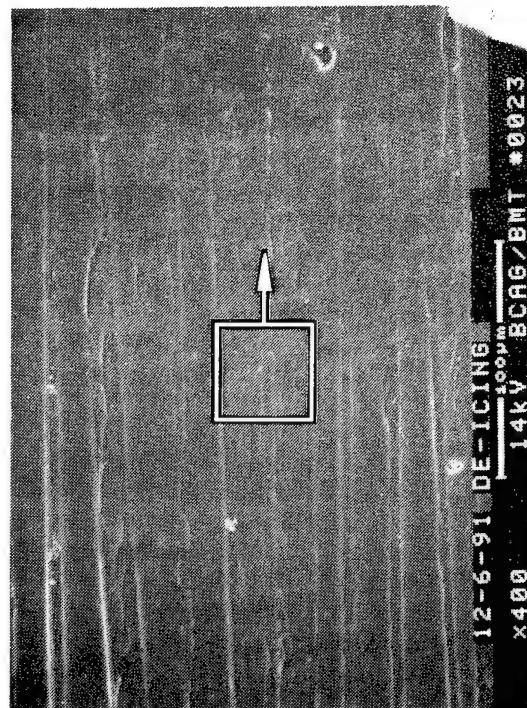
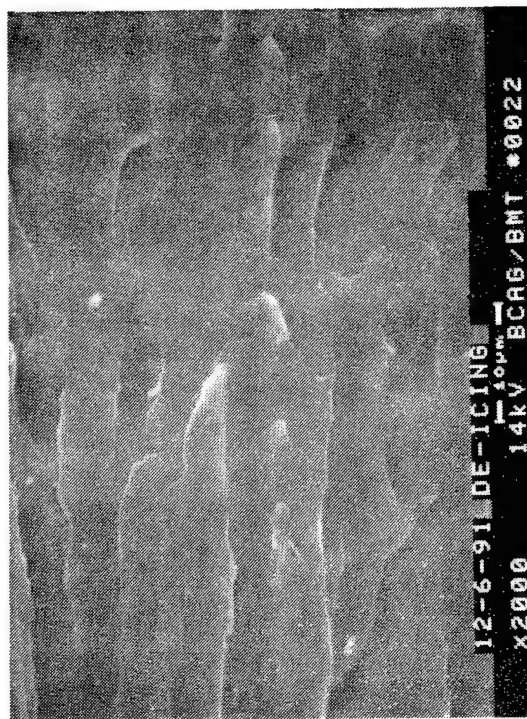
Figure 3.1-8. SEM Fractographs of 3501-6/AS4 Interlaminar Mode I Tension, Specimen Exposed to Deicing Fluid

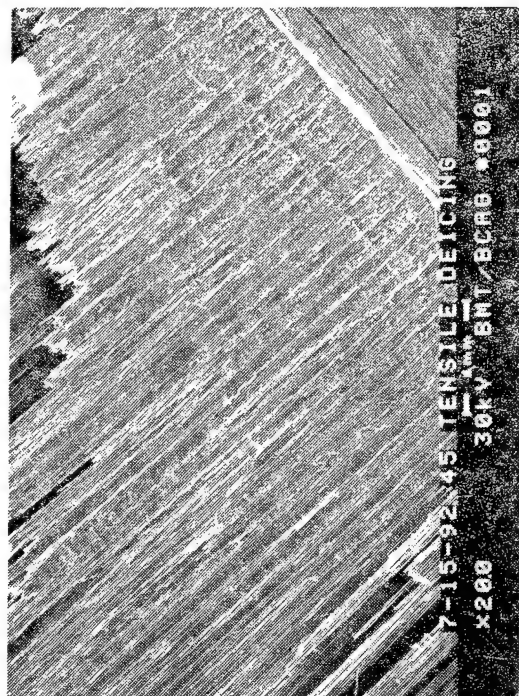
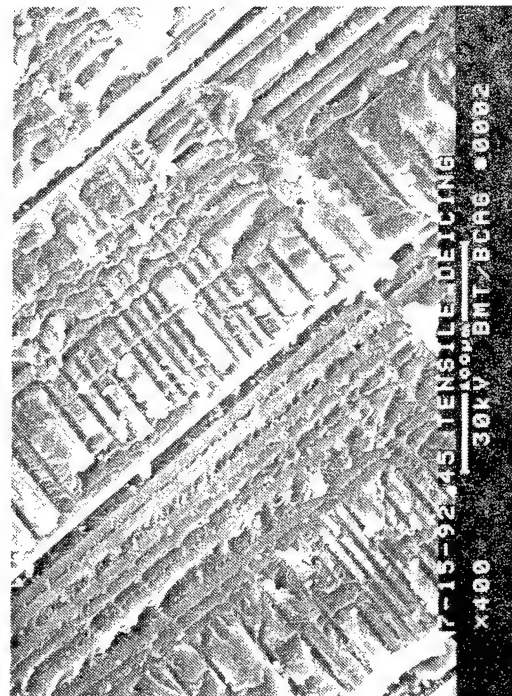
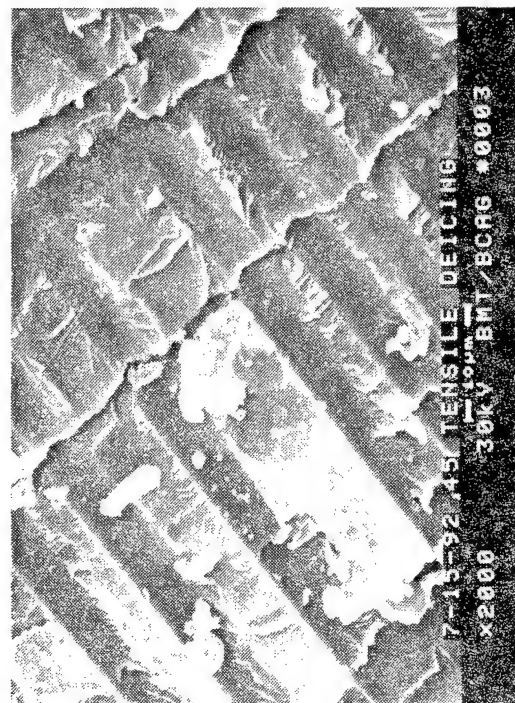
Figure 3.1-9. SEM Fractographs of a 3501-6/AS4  $\pm$  45 Tensile Specimen Exposed to Deicing Fluid, Interlaminar Surface

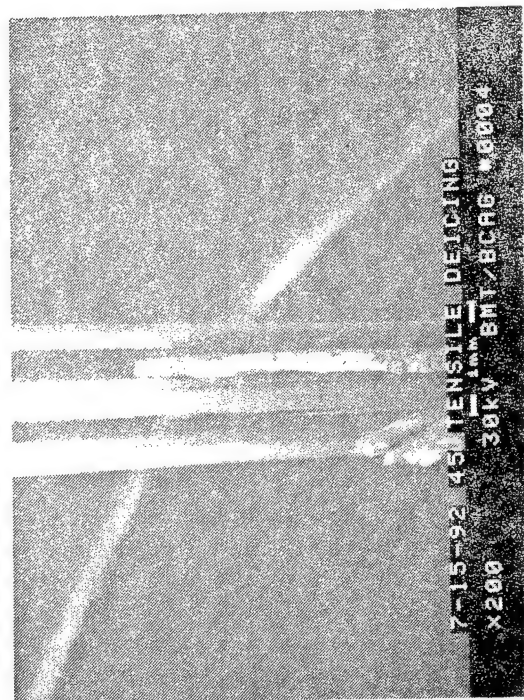
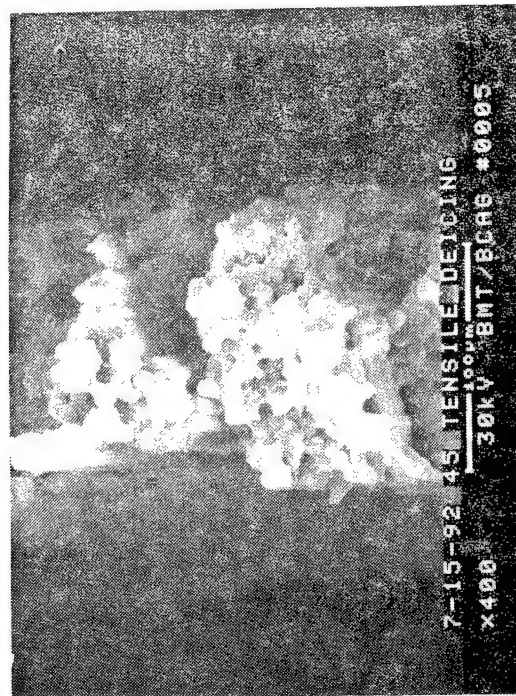
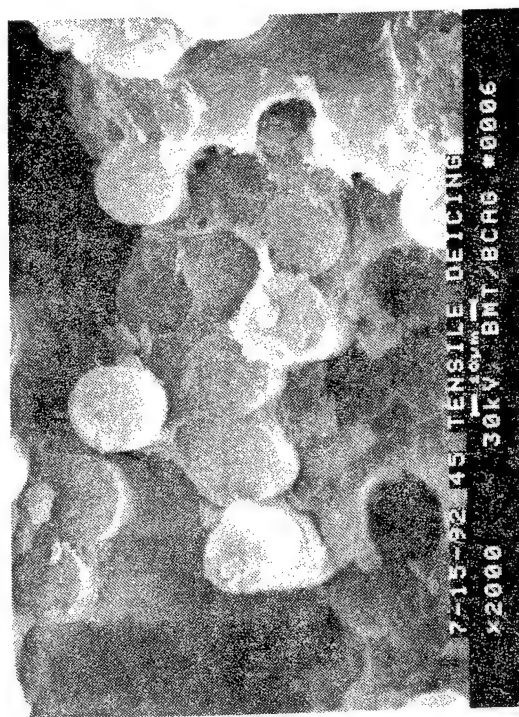
Figure 3.1-10. SEM Fractographs of a 3501-6/AS4  $\pm$  45 Tensile Specimen Exposed to Deicing Fluid, Translaminar Surface

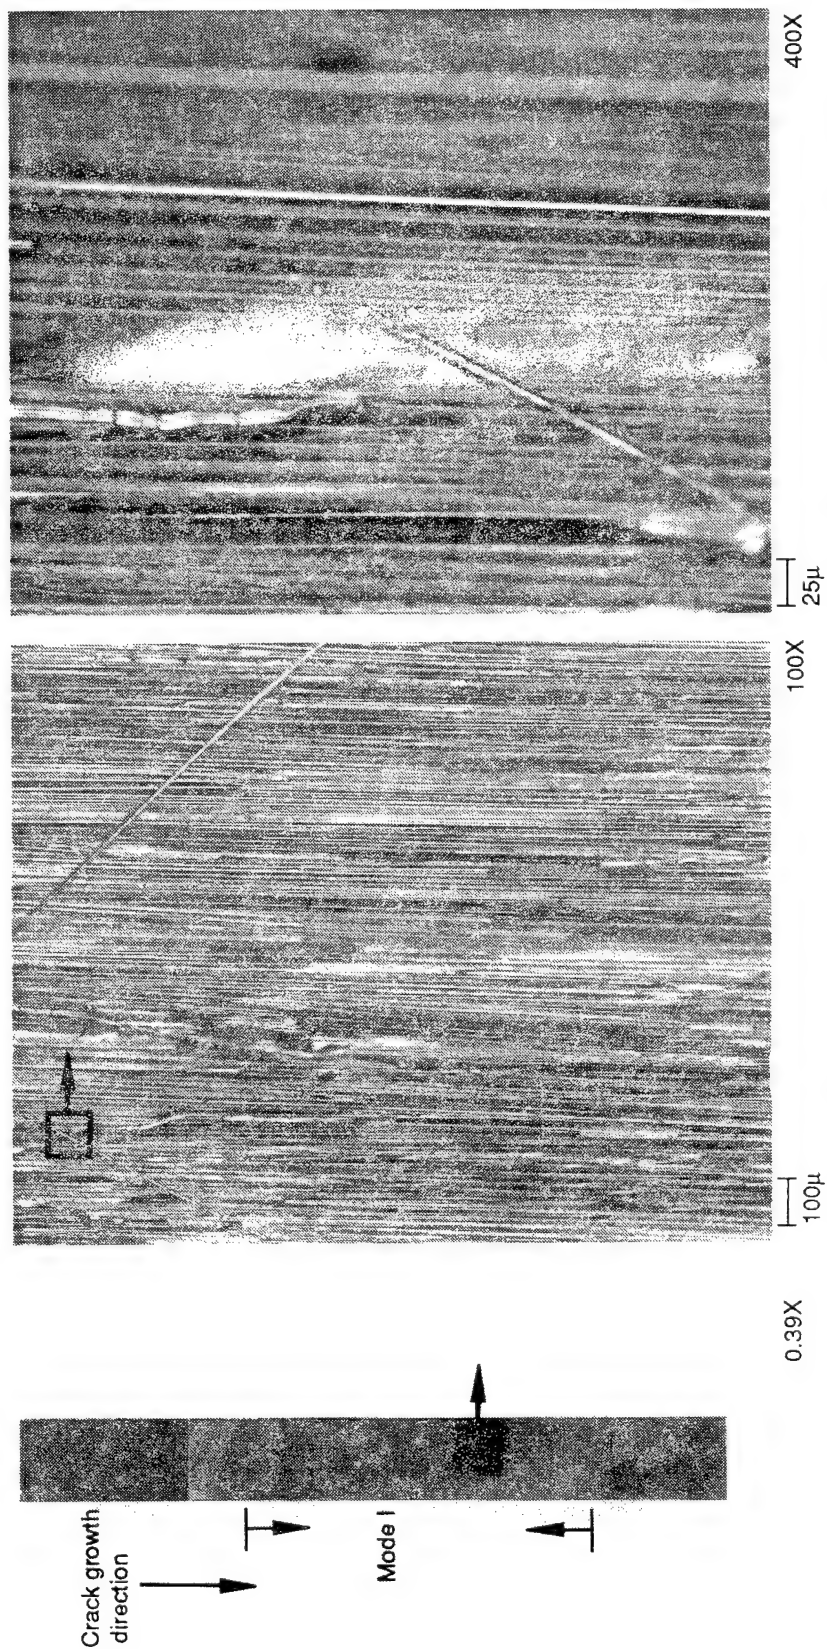
Figure 3.1-11. Optical Fractographs of 3501-6/AS4 Interlaminar Mode I Tension Specimen Tested at -20°F (Freezing Condition)

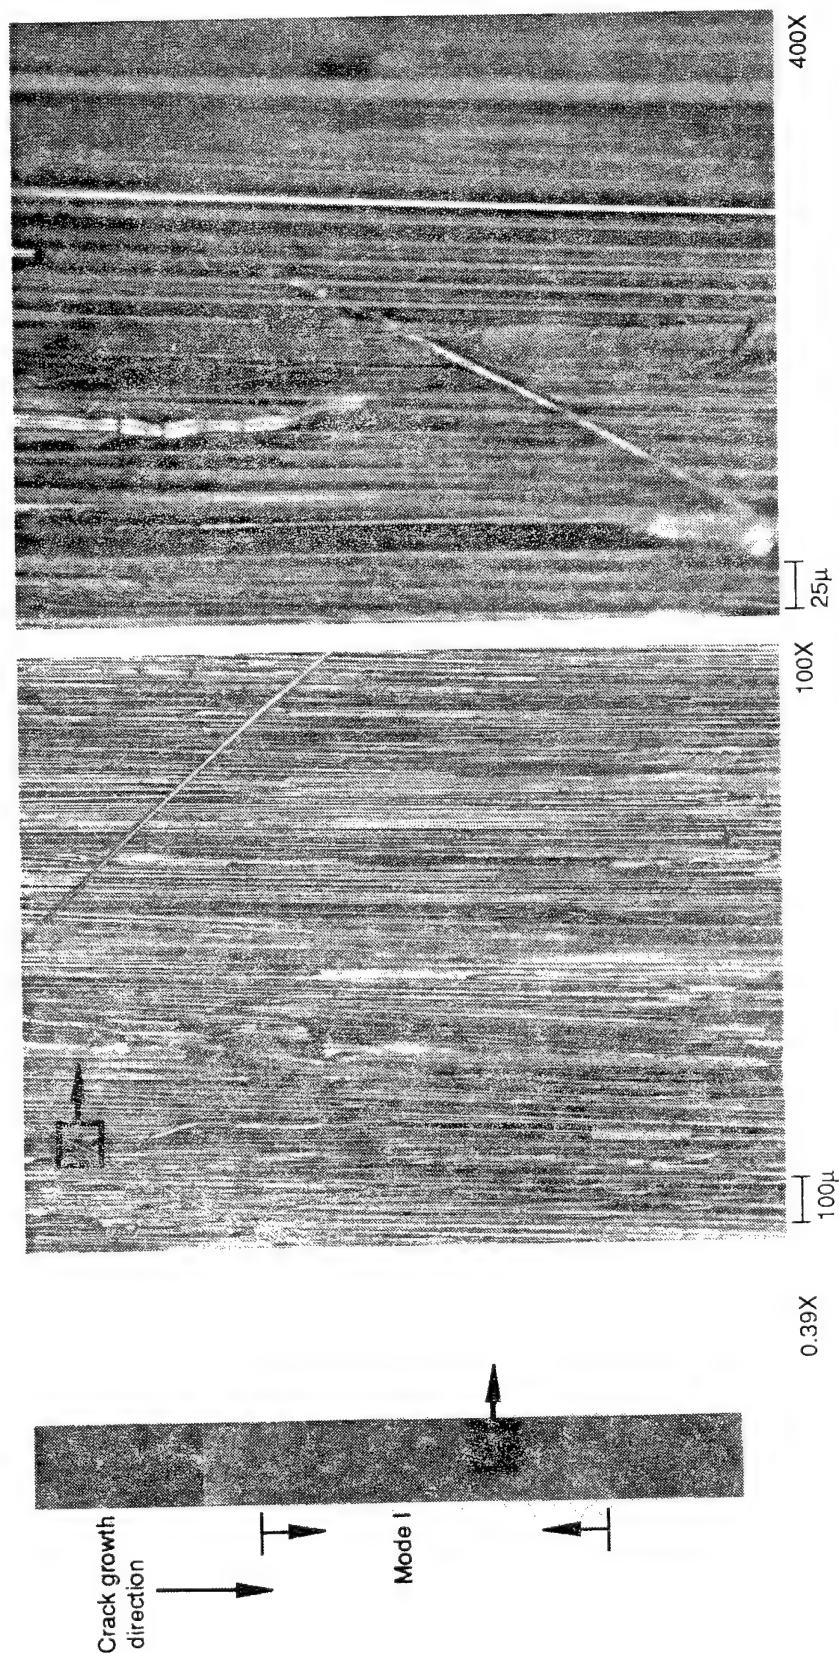
Figure 3.1-12. Optical Fractographs of 3501-6/AS4 Interlaminar Mode I Tension Specimen Tested at -20°F (Freezing Condition)

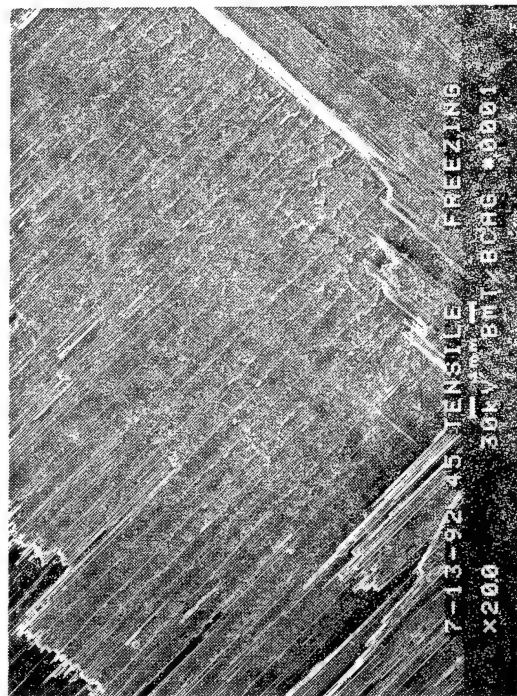
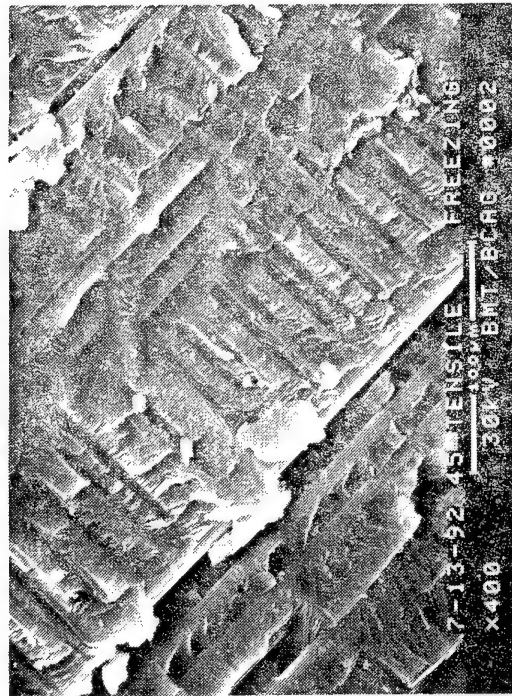
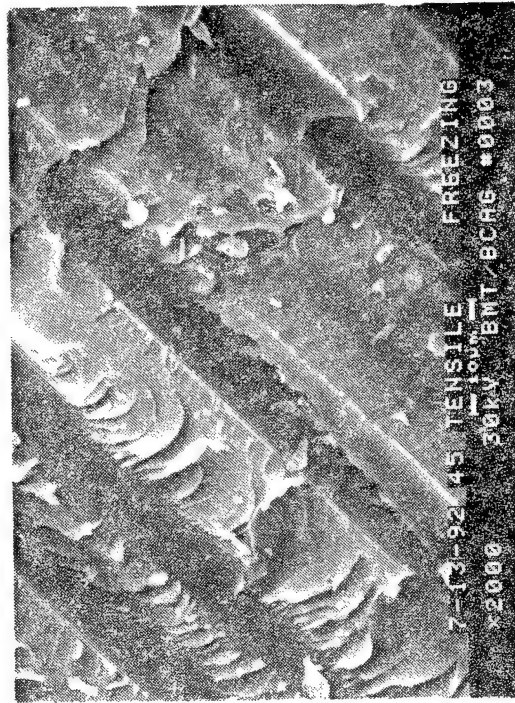
Figure 3.1-13. SEM Fractographs of a 3501-6/AS4 ± 45 Tensile Specimen Tested at -20° F, Interlaminar Surface

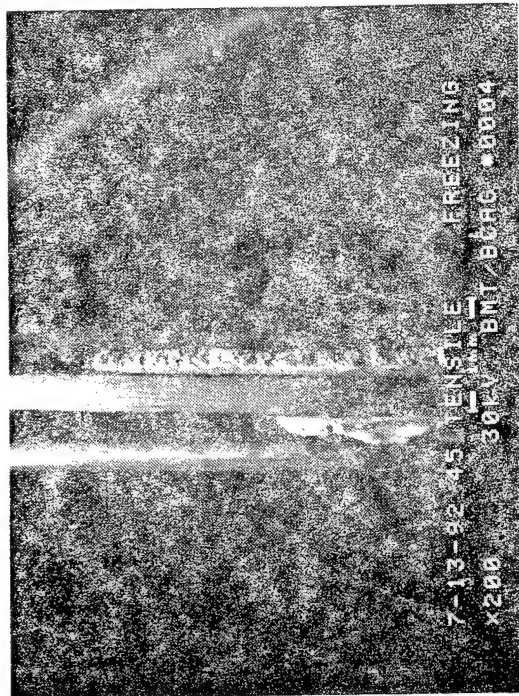
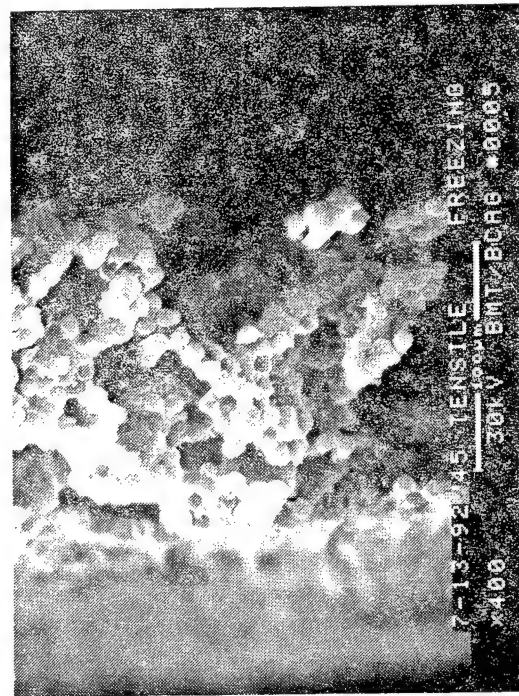
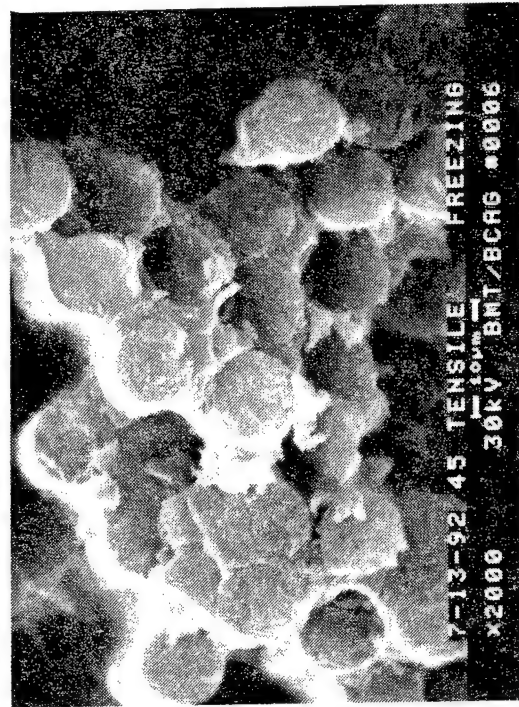
Figure 3.1-14. SEM Fractographs of a 3501-6/AS4 ± 45 Tensile Specimen Tested at -20° F, Translaminar Surface

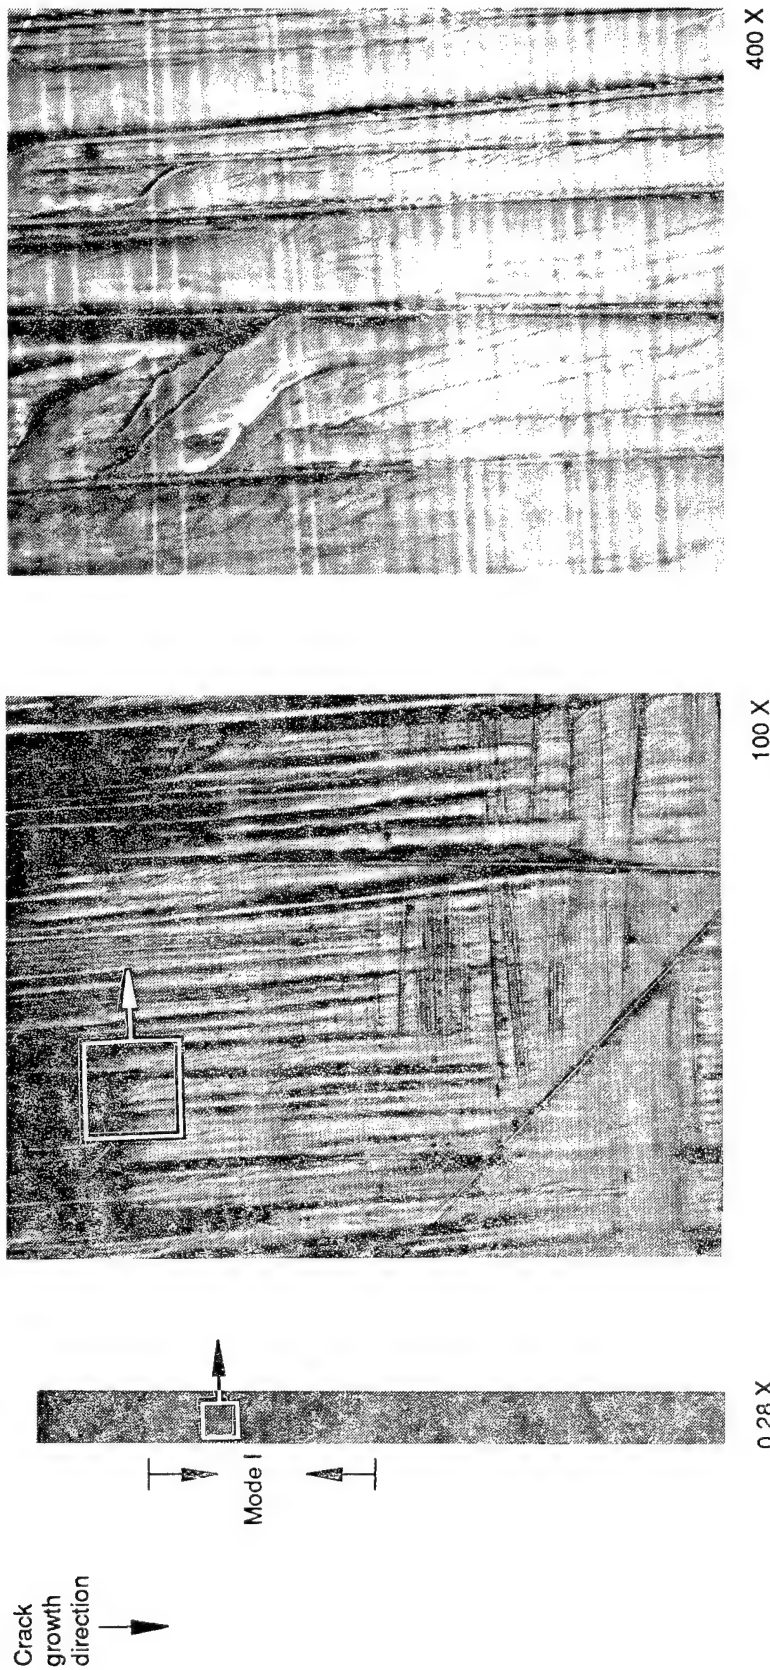
Figure 3.1-15. Optical Fractographs of 3501-6/AS4 Interlaminar Mode I Tension, Specimen Exposed to UV Radiation

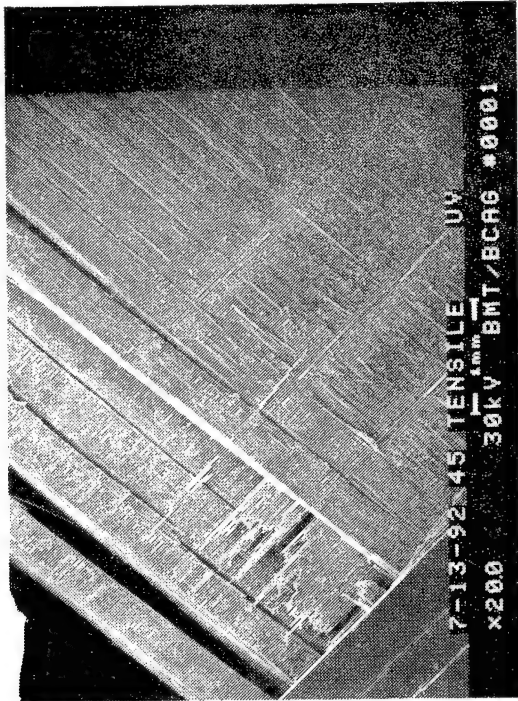
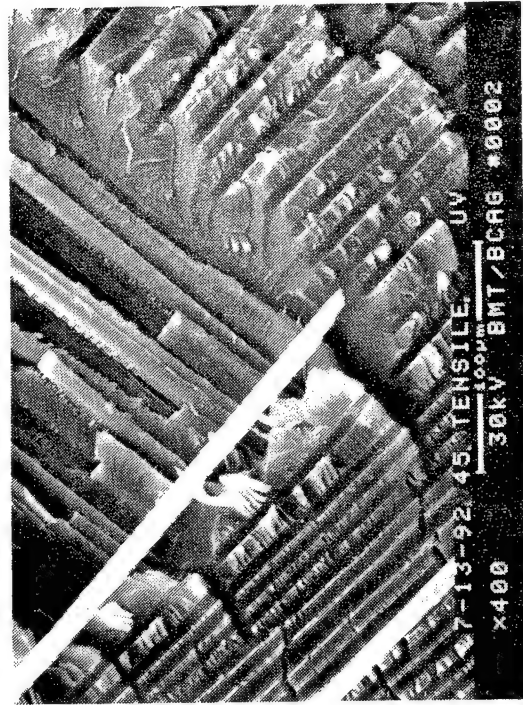
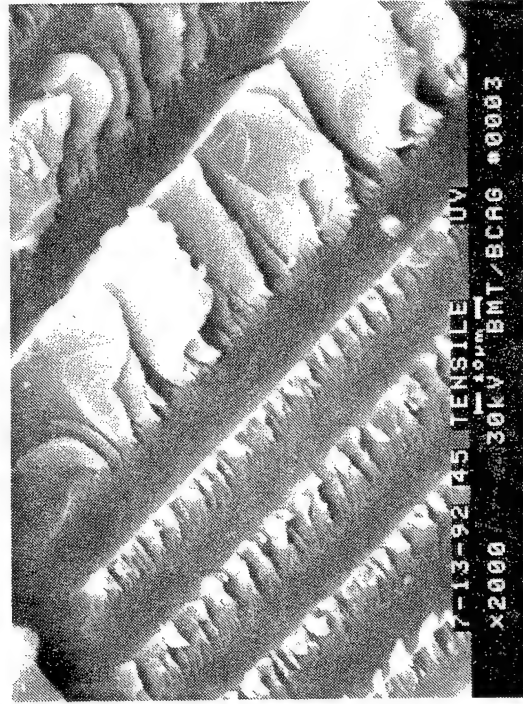
Figure 3.1-17. SEM Fractographs of a 3501-6/AS4  $\pm$  45 Tensile Specimen Exposed to UV Radiation, Interlaminar Surface

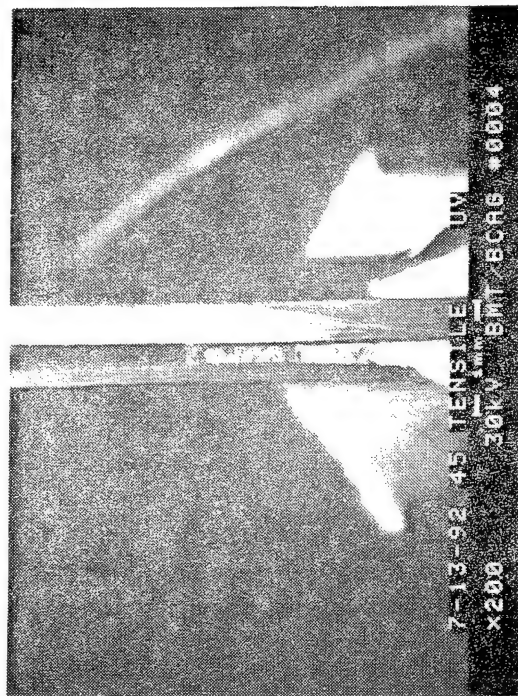
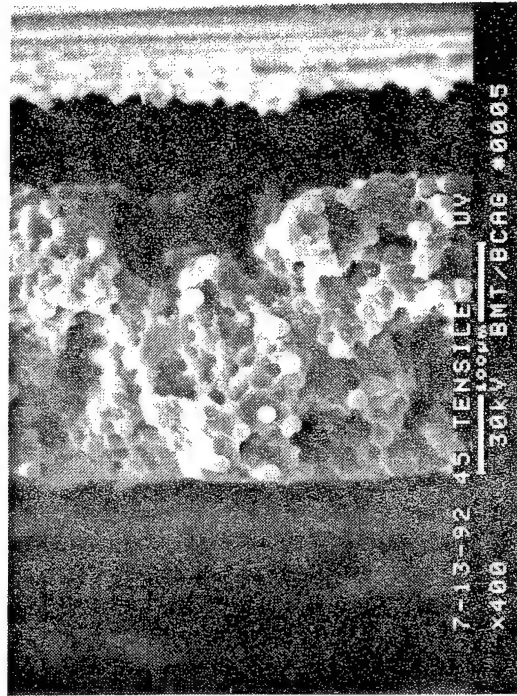
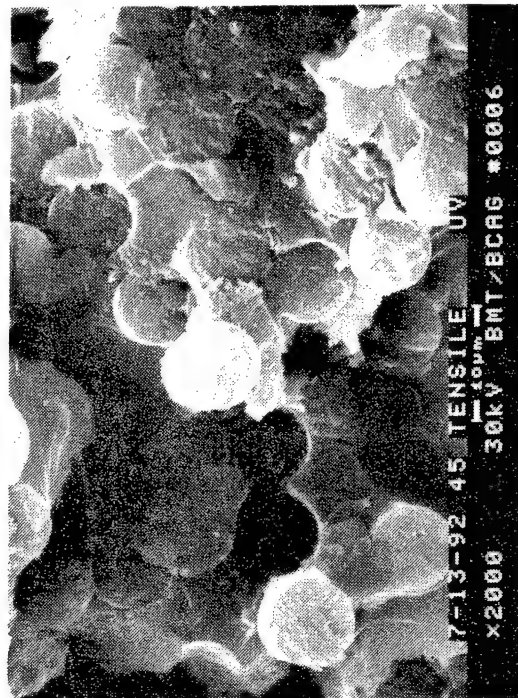
Figure 3.1-18. SEM Fractographs of a 3501-6/AS4  $\pm$  45 Tensile Specimen Exposed to UV Radiation, Translaminar Surface

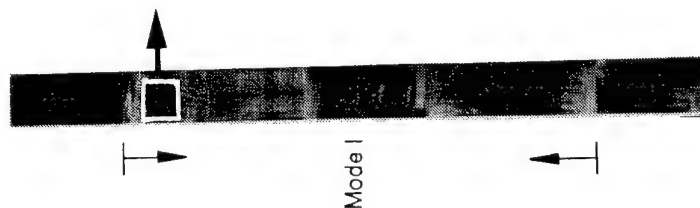
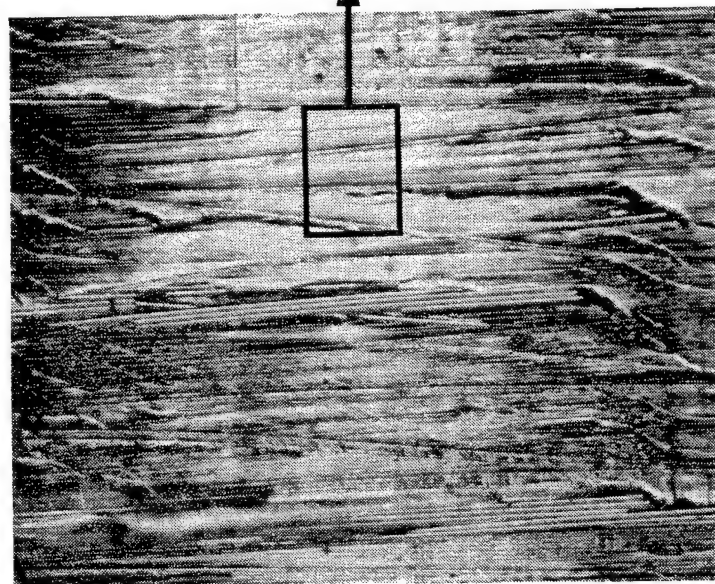
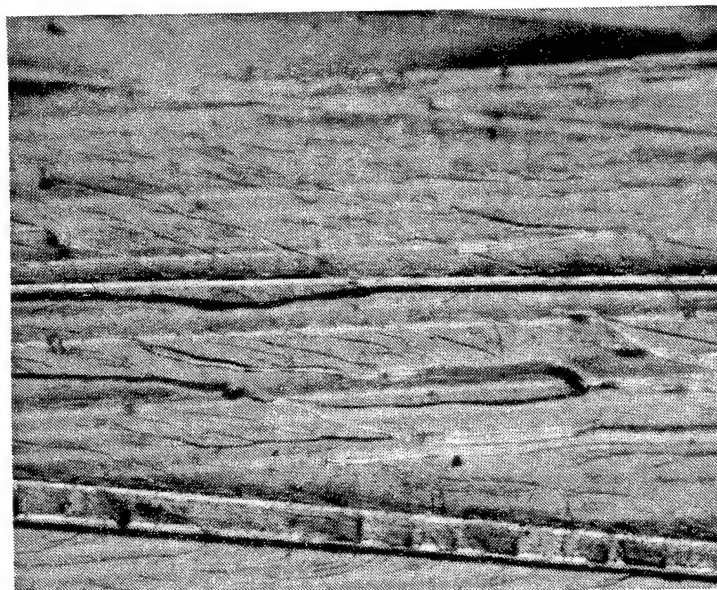
Figure 3.1-19. Optical Fractographs of 3501-6/AS4 Interlaminar Mode I (Tension), Specimen Thermally Cycled Prior to Loading
